## TEST REPORT

No. : TJAT1709010828NM

**Sample Name** : ONERPRO Paint Protection Film  
**SGS Ref No.** : TJIN1709013452MR  
**Date of Receipt** : Sep 25, 2017  
**Testing Start Date** : Sep 26, 2017  
**Testing End Date** : Oct 20, 2017  
**Test Result(s)** : For further details, please refer to the following page(s)

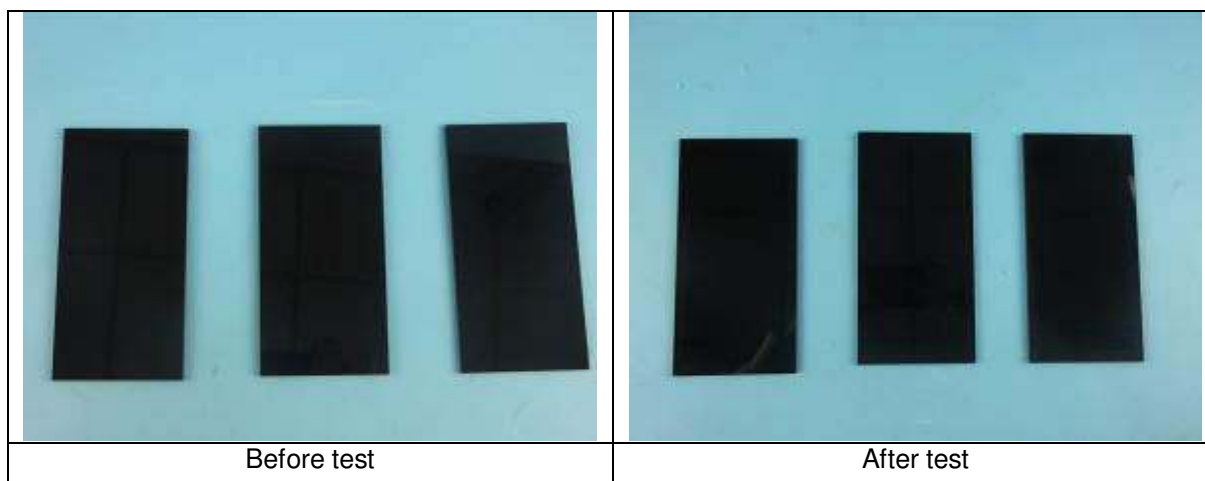
Test Photo:

1. Test Item: Water Resistance (Immersion Method)

Water temperature: 40°C

Duration of the test: 400h

Sample	Test Result	Requirement	Conclusion
1	Paint protection film has no detrimental effect. After ripped off the protect film, paint has no detrimental effect.	Paint protection film has no detrimental effect. After ripped off the protect film, paint has no detrimental effect.	Pass
